Rehabilitation of Plaza De Diego Building in San Juan, P.R. using CFRP

by M. Ehsani

Synopsis: Carbon Fiber Reinforced Polymer (CFRP) products have been used to strengthen a variety of structures. They offer very high tensile strength and offer unique advantages in projects where access is limited. This paper presents the retrofit of a high-rise building in San Juan, Puerto Rico which was necessitated as a result of change in use. Unidirectional carbon fabrics and plates were used to strengthen the floor beams and slabs in flexure. The location of the floor (on the 12th story) and the fact that the partition wall frames were already installed provided unique challenges to this project and limited the strengthening alternatives. The project was completed in time and within budget. Field tests on the installed materials demonstrated that the FRP system met or exceeded the strength values claimed by the materials supplier.

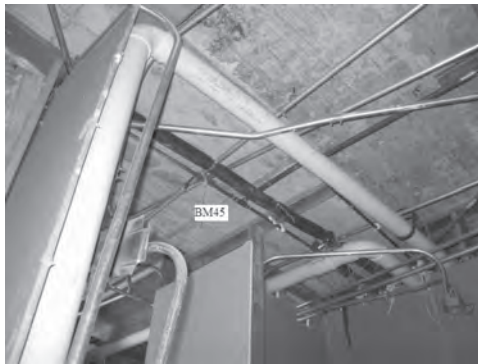
Initially, consideration was given to strengthen the beams with conventional methods, such as the use of new steel beams to carry part of the loads. However, as shown in Fig. 2, there were a number of pipes and utility conduits present that would interfere with such installation. Additionally, transportation of the steel beams to the 12th floor was not an easy task and would have added significant cost to the construction. A further challenge was due to the fact that framing for partition walls was already installed on the entire floor (Fig. 3). This imposed major difficulties. First, it limited access to the underside of the concrete beams. It also made the handling of any steel beams on the floor very difficult.

Figure 2 – Utilities limited access to the underside of the beams

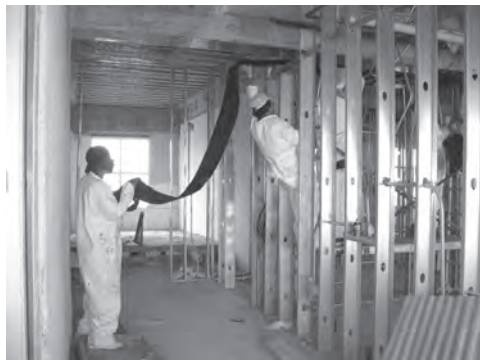
Figure 3 – Partition wall framing limited access throughout the floor

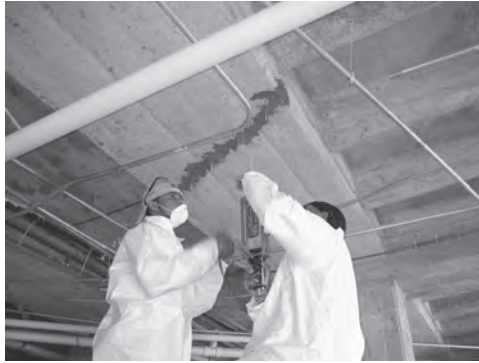
Figure 4 – Crack injection prior to strengthening of beams

Prior to strengthening, the existing cracks that were found in several of the beams were injected with a low-viscosity resin. Figure 4 shows the crack injection. The beam surfaces were then grinded with diamond discs.

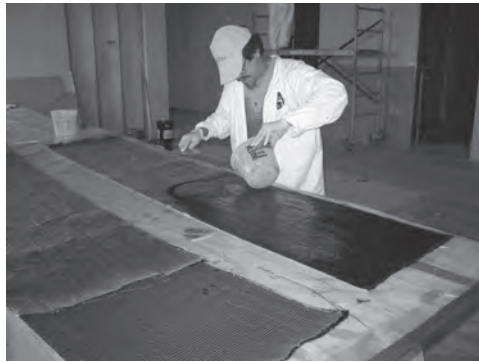
Figure 5 – Saturating of carbon fabrics by hand

Although the FRP supplier does have special equipment to saturate the fabrics, considering the relatively small size of this project, it was decided to perform this task by hand. Working tables were assembled on the 12th floor and after the two-component saturating resin was mixed, it was poured on top of the fabric. The resin is easily worked into the fabric with a putty knife (Fig. 5). A two-component high-viscosity tack coat is also mixed in the field and a 40-mil thick (1-mm) layer is applied to the surface of the beam. The saturated carbon fabric (or the carbon plate) is then applied to the beams. The fabric is pressed to make sure that it is bonded properly and any trapped air is removed. Figure 6 shows a typical installation.

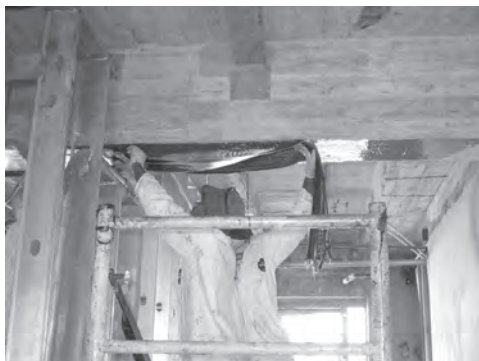
Figure 6 – Saturated fabric is bonded to the beam surface covered with tack coat

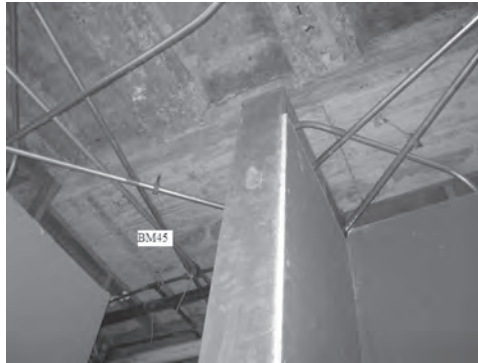
Figure 7 – Partition wall framing crossing the beam axis

Among the salient advantages of FRPs is its versatility. There were instances where the partition walls were already framed to the bottom of the beam (Figs. 7 and 8). The small thickness of the carbon fabrics made the installation much easier in such cases. The upper channel of the partition walls was removed and the fabric was bonded to the underside of the beam. If the partition wall ran along the bottom of the beam (Fig. 8), after the installation of the carbon fabric, steel angles were used to connect the channel to the sides of the beams; this prevented damaging the carbon fabric. In the latter case, this provided a further advantage in that it did not require the removal of the partition wall and the insulating material that was already in place.

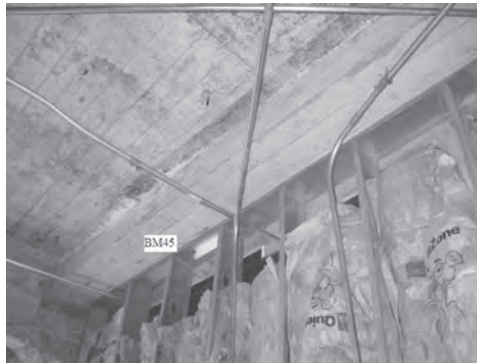
Figure 8 – Partition wall framing running along the beam axis

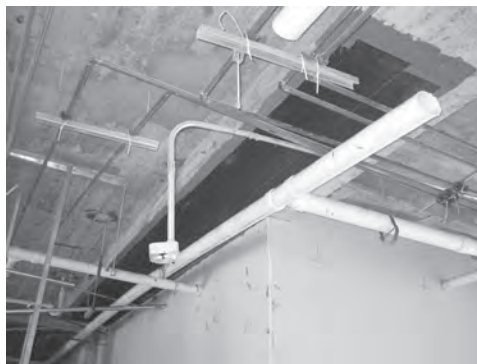
There were a few locations where the bottom of the beams were partially covered by existing partition walls (Fig. 9). Instead of applying a 36-in. 915 mm) layer of carbon

Figure 9 – Two layers of fabric were used when the tension face of the beam was not fully accessible

fabric to this beam, two layers of fabric were applied. The first layer was 30 in. (760 mm) wide and it was bonded directly to the beam; the next layer of fabric was 6 in. (152 mm) wide and it was bonded to the first layer of fabric.

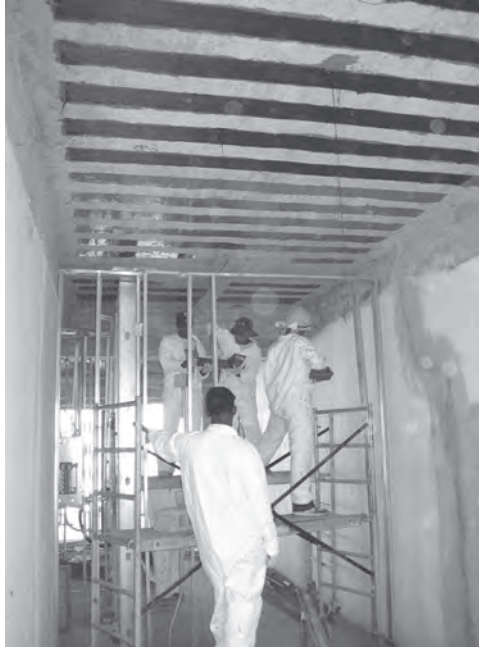
Figure 10 – Strengthening of slab with carbon fabric

In addition to the above beams, there was a 72-ft wide (21.9-m) section of slab that spanned 8 feet (2.44 m). This slab was also reinforced with 6-in. (152-mm) wide carbon fabrics placed at 12-in. (305-mm) on center. Figure 10 shows a portion of the retrofitted slab.
