CARBONSEAL™ INDUSTRIAL COMPOSITE SYSTEMS STEEL PIPE PROJECT

STEEL PROCESS VAPOR LINE REPAIR ALASKA

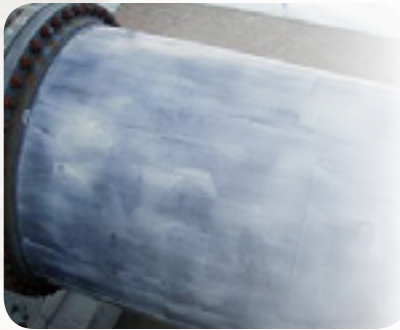
An ASTM A106 – Grade B steel vapor line header at this oil refinery had become corroded both internally and externally, resulting in through holes and a decrease in hoop strength throughout the entire structure.

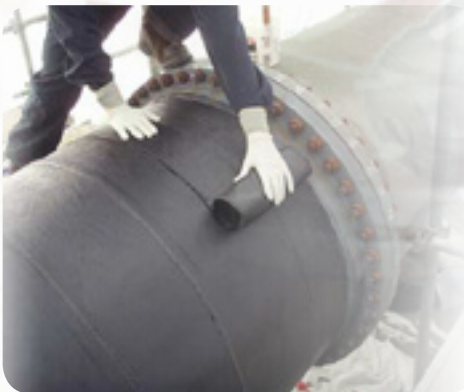
- » Corrosion led to the loss of steel, causing through holes in the 20" pipe
- » The header was connected to a 42" diameter pipe, also needing reinforcement
- » The repair needed to be completed while insuring the internal pipe process did not ingress oxygen, in order to avoid possible combustion
