CARBONSEAL™
INDUSTRIAL COMPOSITE SYSTEMS
STEEL PIPE PROJECT

STEEL RISER WASHINGTON PIPE REPAIR & STRENGTHENING

12 of the steel riser pipes that were part of the circulating cooling system at this oil refinery showed signs of below-grade leaking, and required repair.

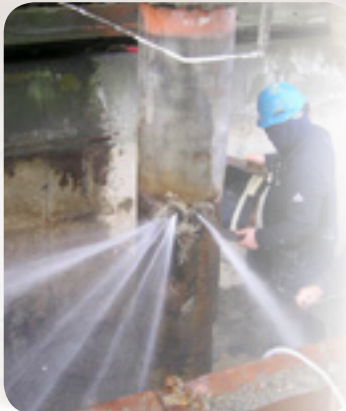
PROBLEM

- » The steel riser pipes had corroded severely due to exposure to moisture and oxygen, resulting in pitting and leaking
- » The pipes were 3/4-inch thick and could no longer maintain a rating of 60psi
- » The plant wanted to avoid any downtime while repairing the 12 risers
