**CARBONSEAL™**  
INDUSTRIAL COMPOSITE SYSTEMS  
**STEEL PIPE PROJECT**

# SUBMERGED STEEL PIPELINE REPAIR

GULF OF MEXICO

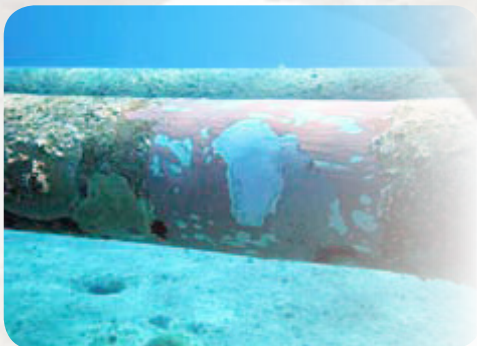
The constant exposure to marine water severely corroded the exterior of this oil transmission pipe.

- » Marine water corroded the exterior of the pipe
- » Multiple leaks were detected
- » A fast and long-term repair was required
