Epoxy-bonded glass fiber-reinforced plastic plates may provide a corrosion-free solution to increasing the load-carrying capacities of concrete bridges.

Fiber Composite Plates Can Strengthen Beams

by H. Saadatmanesh and M. R. Ehsani

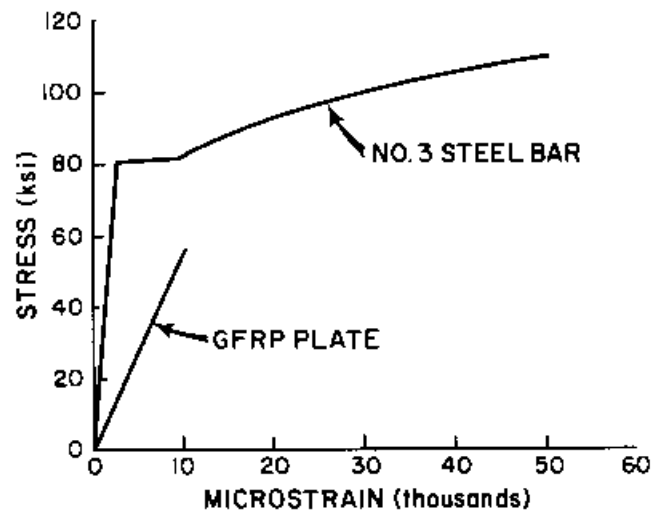
Fig. 3. — Stress-strain relationship of reinforcing steel and GFRP plate.

Materials: Samples of the reinforcing steel and GFRP plate were tested under uniaxial tension. The GFRP exhibited a linear elastic behavior up to failure with a modulus of elasticity of 5,400 ksi (37.2 GPa) and an ultimate strength of 58 ksi (400 MPa) (Fig. 3). The yield strength of the shear reinforcement was 85.5 ksi (589 MPa).

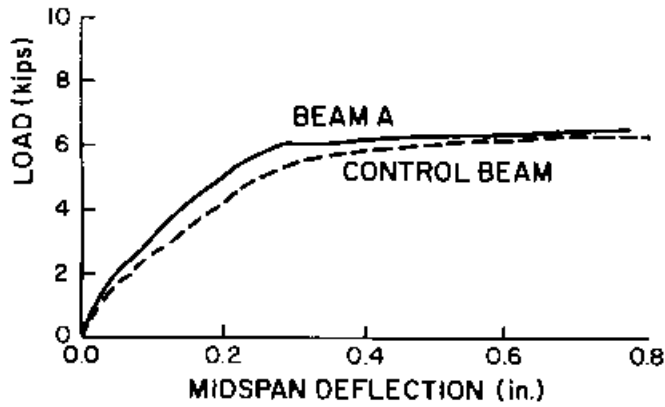
Fig. 4. — Load vs. midspan deflection, beam A.

The initial stiffness was slightly higher than that of the control beam (Fig. 4). The stiffness of both

beams reduced after the concrete cracked at a load of approximately 1.5 kips (6.7 kN). The load-deflection curve then continued almost linearly until the longitudinal steel yielded at a load of 5.5 kips (24.5 kN). At this load large tension cracks developed, the bond between the plate and the beam failed gradually in a ductile manner, and the GFRP plate started to separate from the beam. When failure was reached, with the plate completely separating from the beam over large portions of the span (Fig. 5), there was no visible damage to either the concrete or plate surfaces. Consequently, the control beam and beam A had the same failure load.

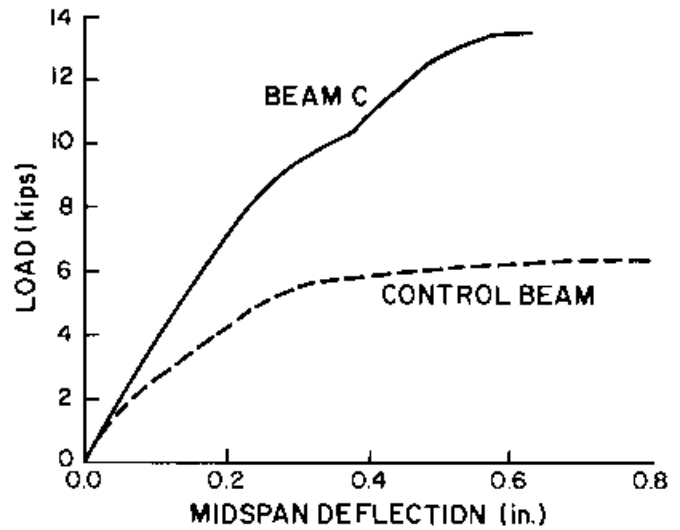
Fig. 8. — Load vs. midspan deflection, beam C.

Beam C was significantly stiffer than the control specimen. It was loaded to failure without any shear distress and reached an ultimate load of 13.54 kips (60 kN), more than twice that of the control specimen. The crack widths in beam C were much smaller than those in the control beam throughout the entire range of loading: there was no visible cracking up to 70 percent of the ultimate load, and thereafter the cracks were very fine and well distributed along the beam.

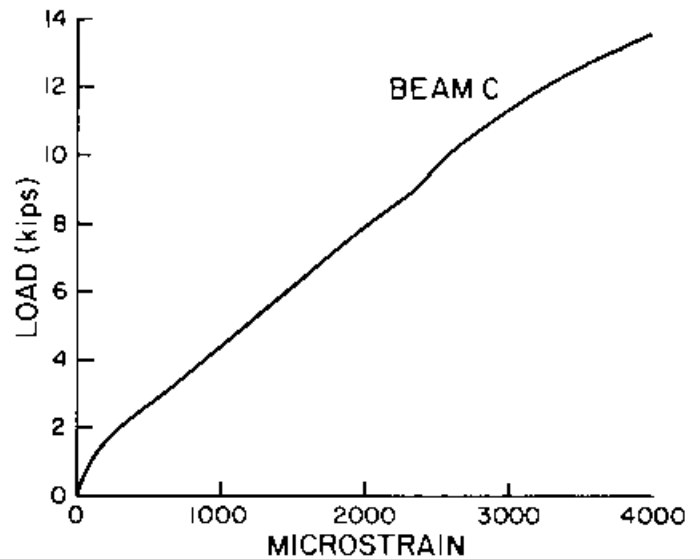
Fig. 10. — Load vs. strain in GFRP plate at midspan of beam C.

The load-strain relationship at midspan of the composite plate was bilinear (Fig 10). After the concrete cracked at a load of about 1.5 kips (6.7 kN), the tension force in the concrete transferred to the GFRP plate, resulting in higher strains. The load-strain curve continued linearly until shear failure occurred in a layer of concrete $\frac{1}{2}$ in. (13 mm) above the plate. The substantial force of 21.6 kips (96 kN) developed in the GFRP plate indicates good shear transfer and composite action between the plate and concrete beam. The average shear stress in the concrete layer that failed was 266 psi (1.83 MPa) at maximum load. This was calculated by dividing the force in the plate by the plate area in the shear span.
