# Laboratory Experiments conducted on Carbon Laminate Interfacial Shear Stress

H. Saadatmanesh

Civil Engineering Dept., University of Arizona, Tucson, AZ, 85721

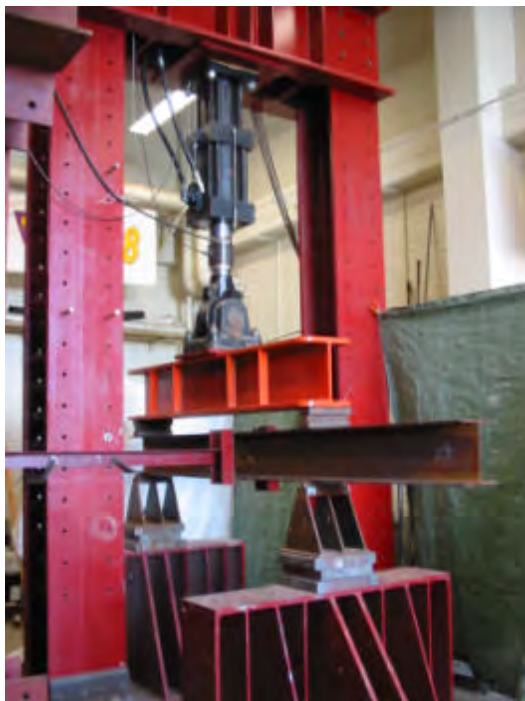
Figure 1. Beam shown after experiment

One center-point load test was applied on a W10x33 beam, composed of A572 Grade 50 ( $F_y = 50\text{ksi}$ ) steel. The beam was 9'-8" long, with a six inch overhang on one end and a thirty-eight inch overhang on the other (Fig. 1). The clear span of the beam was six feet. In the center of the six foot span, the tension flange was cut

The beam test was conducted in the vertical load frame shown in Figure 1. This particular test frame is equipped with a 110 kip MTS actuator, which is supplied by a 30 gpm hydraulic pump. Load was applied at midspan and lateral bracing was provided six inches away from the load point. Rollers were used at all load and reaction locations (Fig. 4).

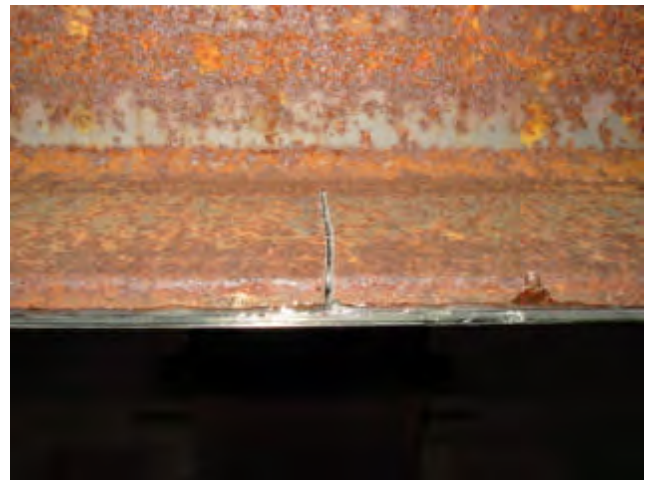
Figure 2. Tension flange cut on both sides of web.

across its entire width (Fig. 2). The beam was then retrofitted by laminating two layers of 0.050 inch thick carbon plate over the full flange width (Fig 3). The laminates were five feet in length, which covered eighty percent of the six-foot tension flange, and were centered about the saw-cut at midspan.

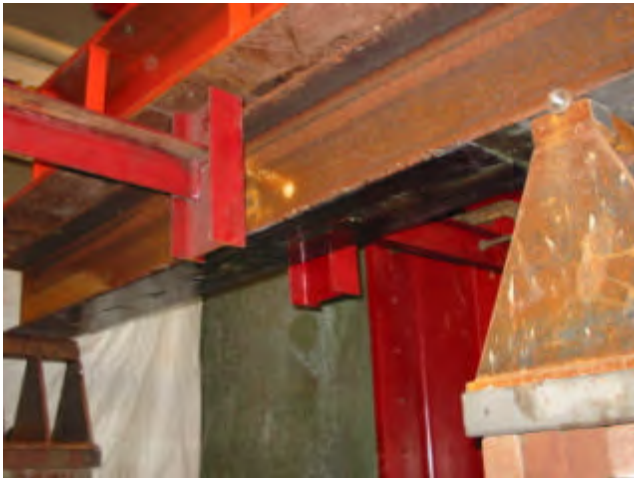
Figure 3. Carbon laminates on tension flange.

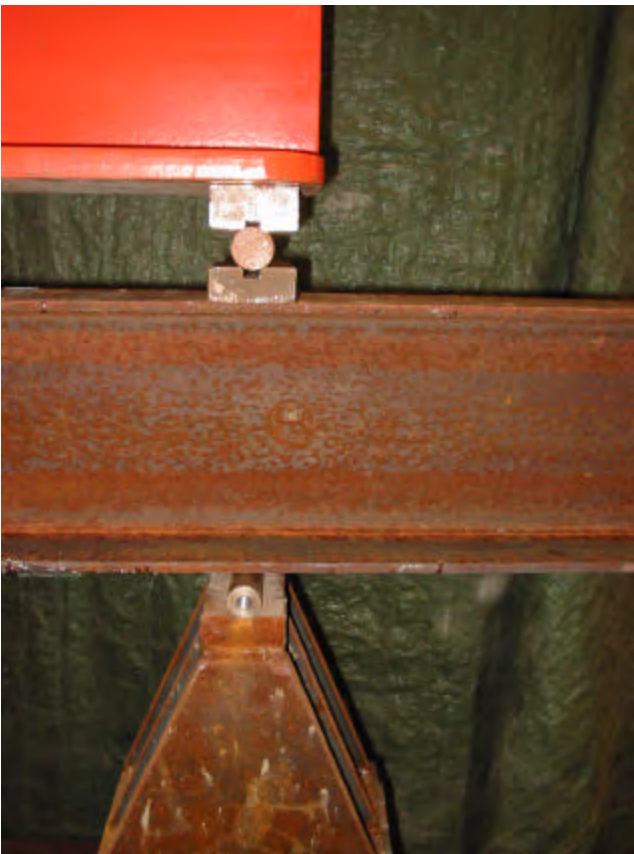
Figure 4. Rollers used during testing. Top roller is not shown in actual location used for testing.

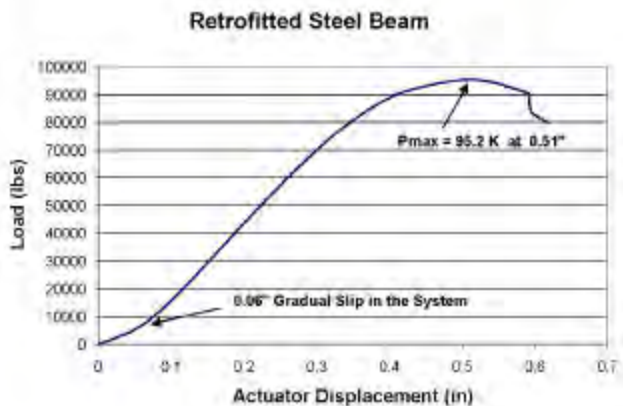
Figure 5. Load vs. Displacement Curve

At the onset of testing, the slip in the system was gradually removed. This continued up to about a 0.06" deflection. At that point, the slope of the load-displacement curve increased dramatically. That slope was maintained up to a deflection of 0.30". At that point the curve began to soften as the beam began to yield (Fig. 5).

The beam reached a maximum load of 95.2 kips at a deflection of 0.51". Shortly thereafter, the load began to decrease with increasing deflection. The test was terminated at a deflection of 0.61" under 80 kips of load. A maximum moment of 1714.6 k" was observed. This is less than the plastic moment for a W10x33 beam, due to the local buckling caused by the non-compact section.

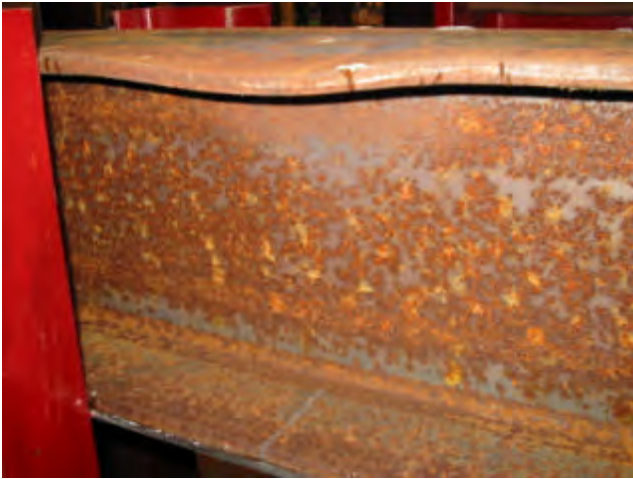
Figure 6. Local deformation of compression flange under point of applied load.

As load increased, the compression flange began to buckle near the point of applied load (Fig. 6). More importantly, the carbon plates did not de-laminate and no other deformations or failures were observed. The bond at the interface of carbon and steel remained intact throughout the entire range of loading; up to the failure of the beam.

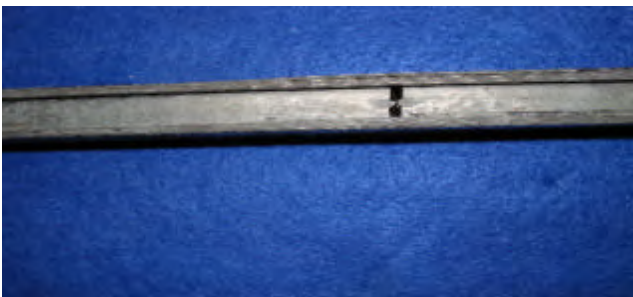
Figure 7. Post-test close-up of the cut made in the steel plate.

Tests were conducted on four coupon specimens. These specimens consisted of 6 layers of 25 oz. carbon fabric and rectangular steel plate. The steel plate was 2" wide, 5/8" thick and 24" long. It was intentionally cut at mid-height, leaving only ten percent of the original area at that cross-section (Fig. 7). A circular grinder was used to prepare the steel plate's entire surface (Fig. 8). After all of the rust and carbon scale had been removed from the steel plate, three layers of the carbon fabric were laminated along 18" of the 24" length on both sides, and were centered at the saw-cut (Fig. 9). The remaining three inches of bare steel on either end were used as the gripping surface in the MTS testing machine.

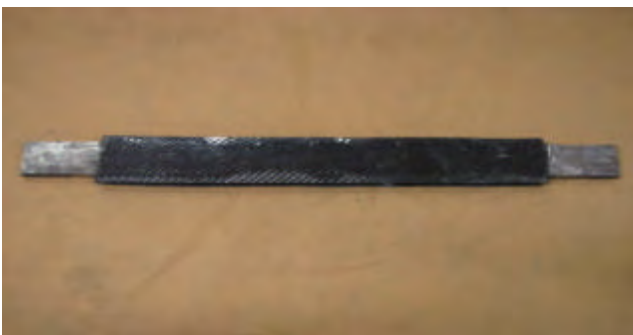
Figure 9. Specimen in pre-test form.

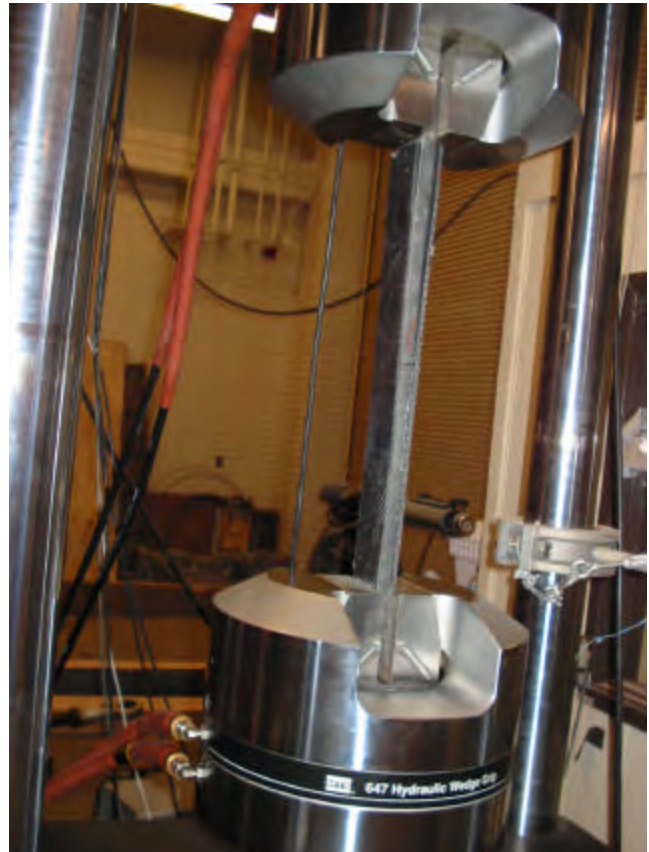
Figure 10. Specimen shown in MTS testing machine with gripping pressure applied.

All three coupons tests were conducted in an MTS vertical testing machine, equipped with a 220 kip actuator and hydraulic grips (Fig. 10). The grips were calibrated to apply 10,000 psi to the ends of the specimen during testing to eliminate any vertical slip. The grip marks can be seen in Figure 8 above. After the specimens were centered and plumbed in the testing machine, axial tension was applied until failure occurred.

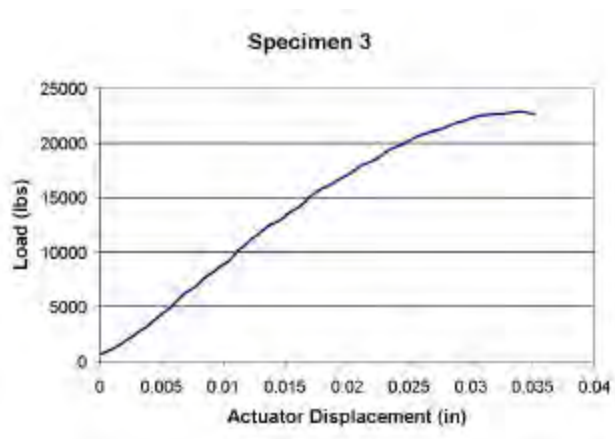
Figure 13. Load vs. Displacement for specimen 3.

entire range of loading for three of the specimens can be seen in Figures 11-13.

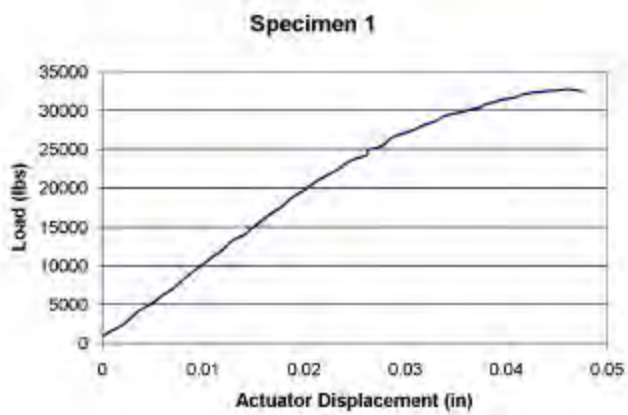
Figure 11. Load vs. Displacement for specimen 1.

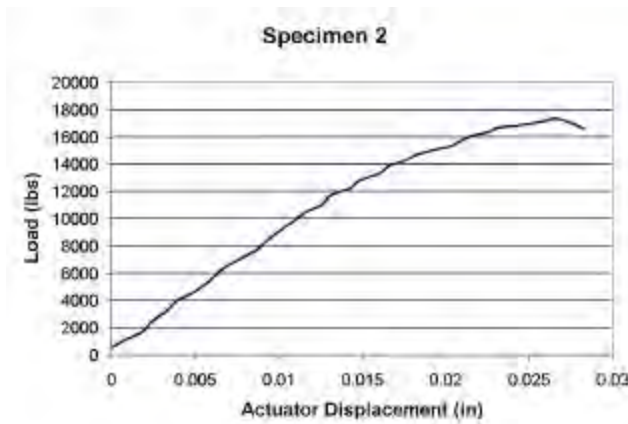
Figure 12. Load vs. Displacement for specimen 2.
