EDITORIAL

Retrofit of Support Columns Exposed to Electrolyte Cells In Copper Mine

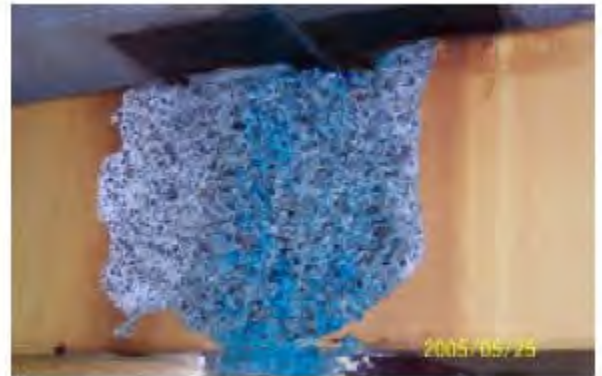
Exposure to electrolyte within the basement of the cell house causes the steel reinforcement within the concrete columns to corrode. Corrosion leads to oxidation within the columns creating an internal pressure that cracks the concrete. Corrosion of the reinforcing steel and delamination of the concrete shell causes structural degradation and failure of the Columns.

Pic 1: Electrolyte Attack of Concrete Structures

The existing R/C Columns were constructed with #8 rebar: 6-inch O.C in the vertical direction and 18-inch O.C. in the horizontal direction. The initial design to repair the columns required coring the columns, inserting #8 Rebar back into the column, and pouring polymer concrete 5 feet high by 8-inch thick to encapsulate the column. The client encountered difficulty coring into the existing columns causing the repair to take over 5 days to complete per column. The excess time to complete the repair increased the cost of repair significantly and caused the client to investigate alternative solutions.

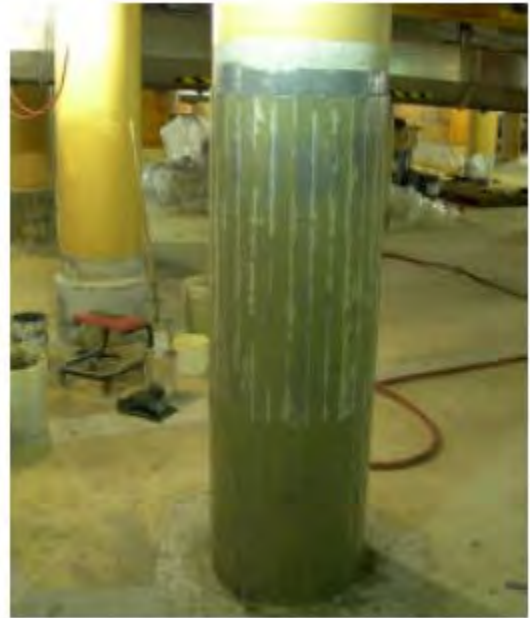
Pic 8: HJ3 System Installed

To develop a solution to replace the traditional method of repair, HJ3 Engineers wanted to create a faster system that would provide equivalent strengthening and greater chemical protection to the damaged columns. Additionally, it was necessary that HJ3 not use conductive materials given the tremendous amount of electricity used in the copper extraction process. Conductive materials in this environment would create significant dangers to installers. The system developed by HJ3 engineers included pre-cured strips of S-Glass Laminate strips in the vertical direction and 30-inch wide S-Glass Fabrics wrapped in the horizontal direction.

First, the substrate of the R/C Columns were prepared by chipping out loose material and abrasive blasting the columns to rid the column of electrolyte. Then a polymer patching material that is tested to withstand the acidic attack from the electrolyte is used to resurface the column. Next, the pre-cured strips of S-Glass Laminate were placed against the surface of the column using the HJ3 TC-300 Tack Coat. The process took 1 day to reinforce 8 columns. To create reinforcement in the horizontal direction, the HJ3 UG30C S-Glass Fabric is wrapped around the S-Glass Laminate strips. Together the HJ3 System provides non-conductive reinforcement equivalent to the steel reinforcement specified in the traditional repair. The repair took 2 days to complete for 8 columns and created a 75% cost savings over the traditional method when considering down time costs.
