CARBONSEAL™ INDUSTRIAL COMPOSITE SYSTEMS STEEL PIPE PROJECT

30" POWER PLANT STEEL RISER REPAIR

ARIZONA

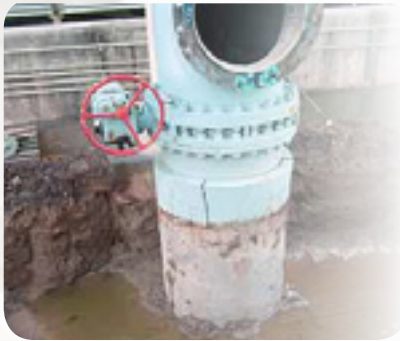
Power Plants utilize a circulating water system to cool steam that has been heated, passed through a turbine, and turned back into water to generate more electricity. Over time, the pipes transmitting the cooling water can corrode. This refinery showed signs of below-grade corrosion and leaking.

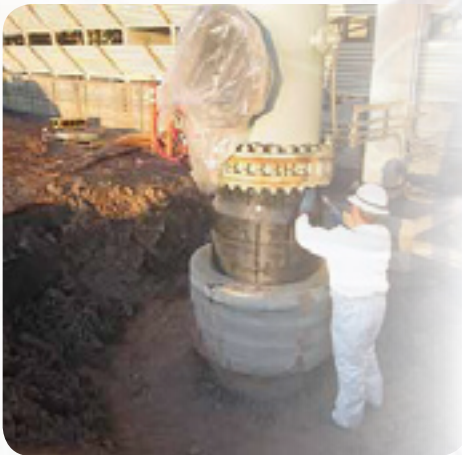
- » The concrete-lined steel riser pipes had corroded and cracked, and water had penetrated the concrete to corrode the steel
- » 2 of the risers had failed as the loss of steel could not support the operating pressure
- » The plant wanted to reinforce the risers from had a minimal outage window for the repair
