STEEL PIPE PROJECT

WATER RESERVOIR

OUTLET PIPE REPAIR

NEVADA

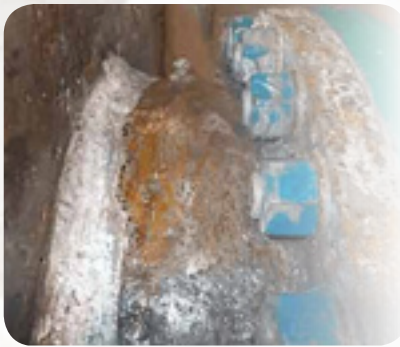
Service reservoirs store fully treated potable water close to the point of distribution. At this underground service reservoir, three outlet pipes had pitting and leaking, requiring repair.

- » Corrosion from exposure to water and oxygen had causing pitting and leaking to the steel outlet pipes along the edge of the concrete tank
- » The reservoir required an NSF-61 approved system that was safe for potable water
- » The reservoir was only out of service for a minimal time, allowing for a small window to complete the repair
