BEHAVIOR OF RETROFITTED URM WALLS UNDER SIMULATED EARTHQUAKE LOADING

By M. R. Ehsani,¹ Fellow, ASCE, H. Saadatmanesh,² Member, ASCE, and J. I. Velazquez-Dimas³

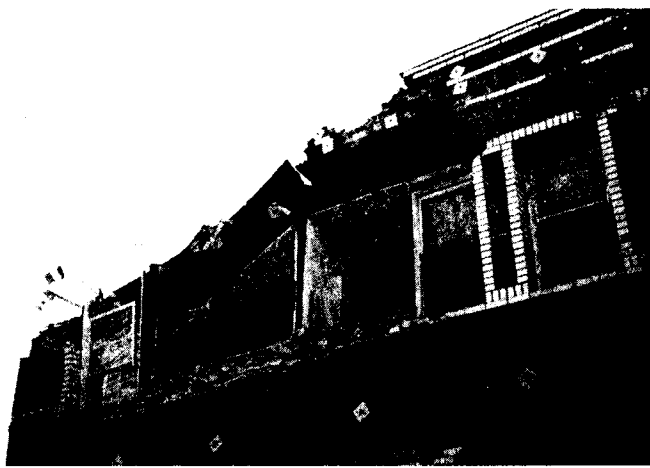
FIG. 2. Failure of URM Wall That Was Retrofitted by Tying Floor Beams to Wall

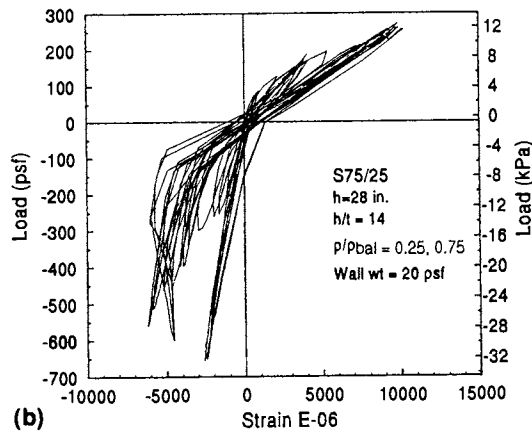
FIG. 6. Specimen S75/25: (a) Load versus Deflection at Midheight; (b) Load versus Longitudinal Strain in GFRP Strip; (c) Load versus Rotation at Top Support; (d) Delamination and Crack Patterns Just before Failure

as the applied pressure increased. Wider cracks were observed on the south face of the wall, where a 2 mm crack width was measured. Cracks spread for almost 75% of the wall area on both faces. Essentially, linear elastic behavior was observed before major crack development on both faces. This resulted in a stiffness degradation, as shown in Fig. 6(a).

Longitudinal tensile strain of 1% in the composite strips was measured on the south face of the wall. A compressive strain of 0.25% was also recorded for the same face. Maximum strains of 1.2% in tension and 0.3% in compression were measured in the composite strips of the north face. In Fig. 6(b), a typical load versus strain curve is shown.

top and bottom ends. Rotations as much as 3.24° and 3.06° were recorded at the top support for both reinforcement ratios, as depicted in Fig. 6(c). Although the north face had three times more reinforcement than did the south face, the last values are fairly close. This is attributed to the excessive delamination suffered by the composite strips on both faces. Thus, the stiffness of the wall degrades to similar values for both faces once excessive delamination begins to control the wall behavior.

Very stiff behavior was observed for the north face. The failure occurred by a sudden peeling of the three strips at the top support. On this face, delaminated areas were located mostly above the middle brick course, as shown in Fig. 6(d). This failure took place at a maximum pressure of 31.03 kPa (4.5 psi) and for an ultimate deflection of 15.5 mm (0.61 in.). Peeling controlled the mode of failure for both faces, although a tensile failure of the fabric was expected due to the relatively

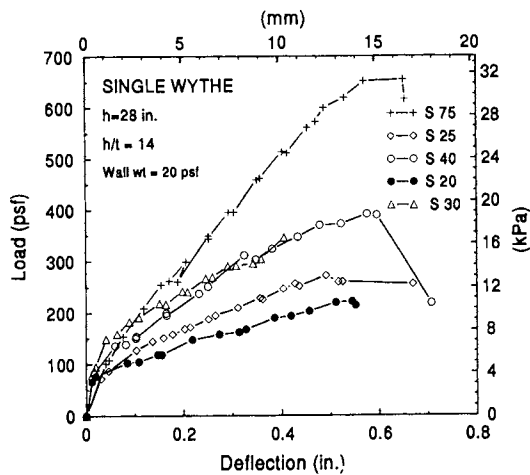
FIG. 9. Maximum Load Envelopes for All Test Specimens

The three URM walls tested had the same height-to-thickness ratio ($h/t = 14$), and were retrofitted using the same epoxy and primer. Two different glass fabric densities and five reinforcement ratios were investigated. The load-deflection envelopes for the three walls are presented in Fig. 9. For nonsymmetrically retrofitted walls, the ultimate deflection was practically the same. However, within the range of reinforcement ratios investigated in the present study, the ratio of the

maximum supported lateral pressure by each face of a given wall was proportional to the amount of reinforcement. For specimens retrofitted with unidirectional fabric, i.e., S75/25 and S20/40, the ultimate deflection appears to be independent of the reinforcement ratio. The longitudinal tensile strains on the composite fabrics were similar in all specimens; i.e., about 1%–1.2% for most cases.
