GALVANIC CORROSION OF CARBON AND STEEL IN AGGRESSIVE ENVIRONMENTS

By Mohammadreza Tavakkolizadeh,¹ Student Member, ASCE,
and Hamid Saadatmanesh,² Member, ASCE

ABSTRACT: The demand for the use of carbon-fiber-reinforced plastics (CFRP) in rehabilitation of deteriorating infrastructure is increasing worldwide. The design characteristics of reinforced concrete or steel members can be enhanced significantly by epoxy bonding CFRP laminates to the critically stressed tension areas. There is, however, a concern regarding possible galvanic corrosion when carbon and steel are bonded together. This paper presents the result of a study on the galvanic corrosion between CFRP laminates and steel. A total of 38 specimens made of steel and carbon fibers were prepared and tested. Two simulated aggressive environments and three different amounts of epoxy coating were used in addition to samples with no coating at all. Furthermore, the effect of the sizing agent on the galvanic corrosion rate was investigated, and three different solvents were used to remove the sizing agents from the surface of the carbon fibers. Potentiodynamic polarization and galvanic corrosion tests were conducted. The result

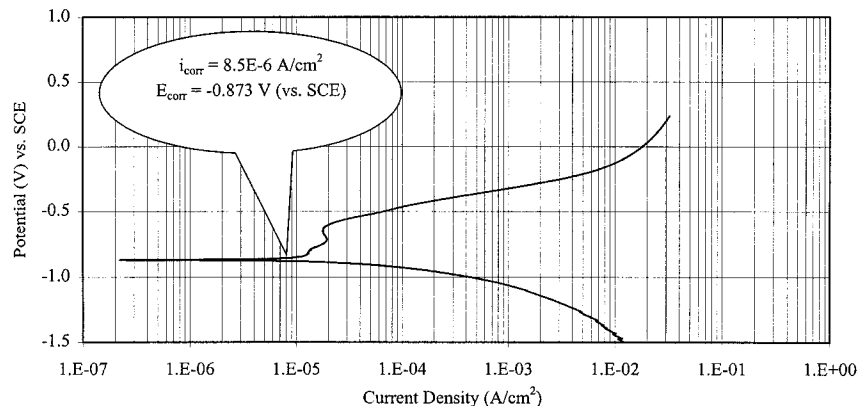
**FIG. 9.** Polarization Curve for Steel in Deicing Solution

In Fig. 9, it is clear that steel in deicing salt solution showed a minor sign of passivation along the anodic segments. Passivation indicates a situation in which a metal is temporarily protected from further corrosion by a thin film of corrosion product on its surface. The rate of corrosion is proportional to the corrosion current density (through Faraday's law) obtained from these diagrams. For steel, the anodic reaction is the oxidation of the metal or corrosion. In the case of CFRP, the anodic reaction is the oxidation of carbon that causes the degradation of the composite. Considering the pH of the electrolytes (7.90 for deicing salt solution and 7.25 for seawater), the cathodic reaction for both materials is the reduction of oxygen and the formation of hydroxide ion (OH^-) on the surfaces.

The corrosion potentials of carbon specimens were higher than those of steel in both solutions. As shown in Figs. 9 and 10, steel corrosion potential in deicing salt solution and seawater were -0.873 and -0.766 V versus SCE, respectively. The CFRP corrosion potentials were -0.196 and -0.244 V versus SCE, as shown in Figs. 11 and 12, respectively. Therefore, the carbon is more "noble" than steel in both electrolytes.

Meanwhile, the corrosion current densities of CFRP were higher than those of steel in both solutions. As shown in Figs. 9 through 12, the CFRP corrosion current densities were 1.5×10^{-5} , 1.7×10^{-5} A/cm² compared to those of steel, which were 8.5×10^{-6} , 3.9×10^{-6} A/cm² in deicing salt solution and seawater, respectively.

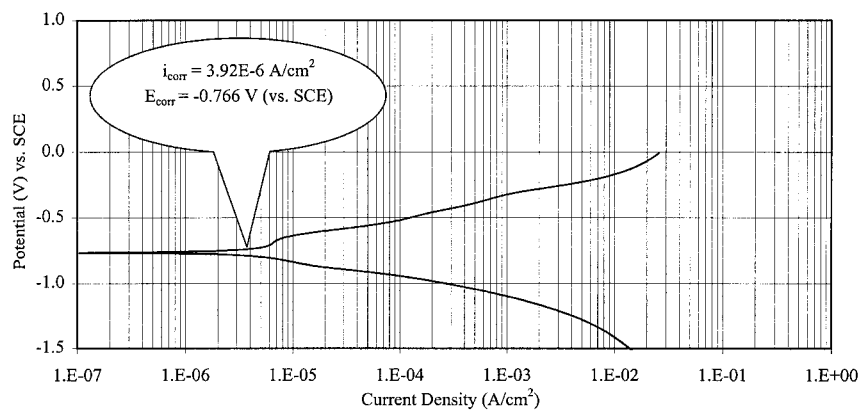
**FIG. 10.** Polarization Curve for Steel in Seawater

Steel, when coupled with carbon, showed a faster corrosion rate in both solutions. In contrast to the corrosion rates noted in Figs. 9 and 10, when coupled with carbon in seawater, the rate increased from 3.9×10^{-6} A/cm² to 1.8×10^{-5} A/cm² (0.25 mm coating), 8.5×10^{-5} A/cm² (0.10 mm coating), and 3.77×10^{-4} A/cm² (bare fibers). Analogously, in a deicing

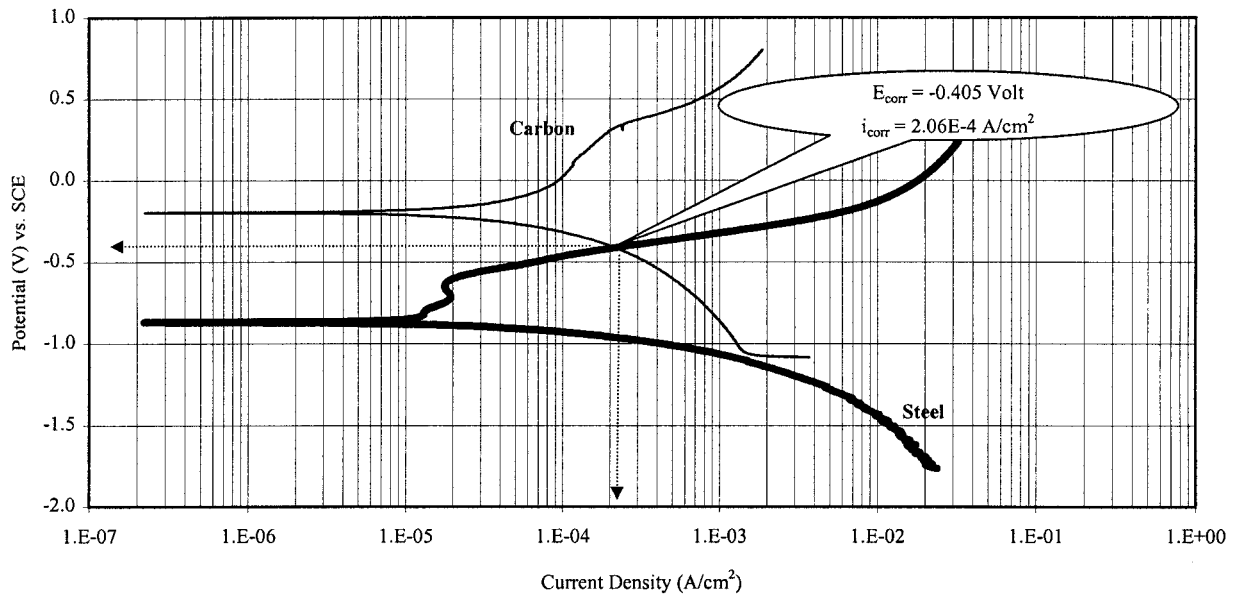
FIG. 13. Evans Diagram for Carbon Composite with Thin Epoxy Coating in Deicing Solution

Steel tends to corrode faster when coupled with carbon in these solutions. The plots of steel and carbon for each solution were superimposed, as shown in Figs. 13 and 14. In order to

estimate the corrosion rate of the steel when coupled with carbon in each solution, the intersection of the two polarization plots of carbon and steel in the same solution on the Evans diagram was found. In both cases, the anodic polarization curves for steel (corrosion of steel) intersect the cathodic polarization curves for carbon (oxygen reduction on carbon). Corrosion current densities, i_{corr} , for the coupled systems were determined as 2.06×10^{-4} and 2.27×10^{-4} A/cm² for deicing salt solution and seawater, respectively. The values of i_{corr} for steel in deicing salt solution and seawater using Figs. 9 and 10 were 1.5×10^{-5} and 1.7×10^{-5} A/cm², respectively. Therefore, when coupled with carbon, steel corroded 13.7 and 13.4 times faster in the deicing salt solution and seawater, respectively, than in the absence of carbon. In both solutions, hydroxide ions were formed around carbon fibers inside the matrix as a byproduct of oxygen reduction.

For a more accurate measurement of the corrosion rate, galvanic corrosion tests were also performed. This was accomplished in two stages. The effects of different types of CFRP for the two solutions were examined. By testing four pairs of carbon specimens with different thicknesses of epoxy coating in deicing salt solution and seawater, both parameters (thickness of epoxy coating and type of solution) were investigated. The results of the galvanic corrosion tests are shown in Fig. 15. After 1,000 s, all the experiments reached steady state, and the galvanic current density of each test was obtained. The galvanic corrosion current density for the steel coupled to carbon specimens with the thin film of epoxy coating were 0.93×10^{-4} and 0.85×10^{-4} A/cm² in deicing salt solution and seawater, respectively. These values were confirmed by the results of the polarization tests shown in Figs. 13 and 14 (2.06×10^{-4} and 2.27×10^{-4} A/cm² in deicing salt solution and seawater, respectively).
