Out-of-Plane Behavior of Brick Masonry Walls Strengthened with Fiber Composites

Juan I. Velazquez-Dimas, Mohammad R. Ehsani, and Hamid Saadatmanesh

ACI Structural Journal, V. 97, No. 5, May/June 2000.

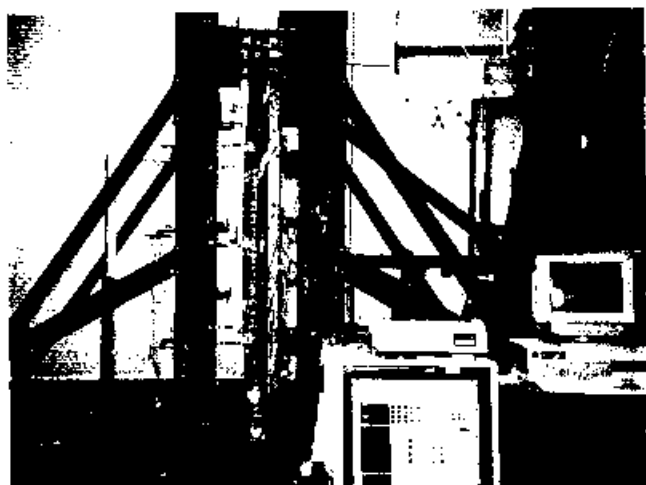
Fig. 4—Test setup.

The four walls were tested in a steel reaction frame. The specimens were simply supported along the top and the bottom edges, and the two vertical sides were free. With these boundary conditions, it was intended to reproduce a portion of the wall free of corner and joint interference. A roller condition was provided at the top, i.e., vertical displacements and rotations were allowed. The specimens were subjected to cyclic out-of-plane loading. The lateral pressure was applied through an airbag system that was moved from one face of the wall to the other; more details about the test setup are presented elsewhere (Velazquez-Dimas 1998). The load was applied to the walls in two stages: a load-controlled stage, which consisted of two pairs of cycles to observe the uncracked behavior; and a displacement-controlled stage,

where the maximum displacement in each pair of cycles remained constant. The stiffness degradation was monitored using two loading cycles for the same displacement level. This procedure was continued until the failure of the wall was reached. To exclude the beneficial effect of overburden pressure, no axial load was applied to the specimens. An overall view of the testing frame showing the double wythe wall is given in Fig. 4. The maximum deflection at midheight of the west edge and the applied pressures were monitored in real time by two voltmeters, and the corresponding load versus deflection curves were plotted on the monitor of the data acquisition system.

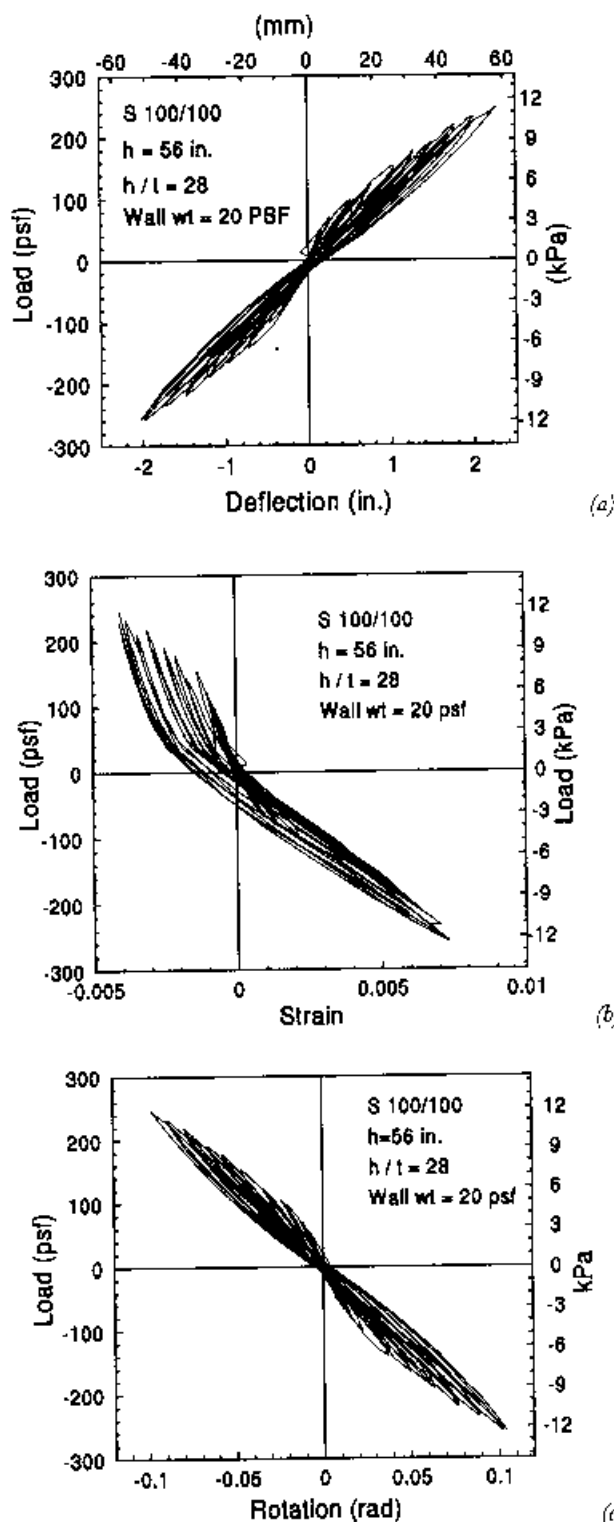
Fig. 5—Typical measurements for Specimen S 100/100: (a) load versus deflection at midheight; (b) load vs. the longitudinal strain in the composite strip; and (c) load versus rotation at the top support.

Delamination is another factor that produces loss of stiffness. The first delaminated areas were observed on the north face during the fourteenth cycle at an applied pressure of 7.6 kPa (158 psf), and a deflection of 25 mm (1.0 in.). These delaminated areas were marked on the central composite strip above the middle brick course. Delaminated areas are often accompanied by sounds of the epoxy breaking away from the brick surface, and result in enlarged hysteretic loops. Similar behavior was observed for the south face as shown in Table 1, where close correlation is shown for both faces. In Fig. 5(a),

the first significant stiffness degradation seemed to be more influenced by the formation of large cracks along bed joints rather than the formation of the first delaminated areas. After these two major damages occurred, the additional cycles of loading resulted in further delamination of the fabric strips.

Rotations on the west and the east wall edges of the wall were also measured. From the recorded data, this wall rotated at the top and the bottom supports up to 6 degrees. This gave an indication of how the composite strips can transform a brittle wall into a flexible one. In Fig. 5(c), a typical load-versus-rotation curve is depicted for a clinometer attached to the top west corner. This curve also confirms the symmetry that was mentioned previously. In addition, measured rotations at midheight were almost zero, indicating that the pressured applied by the airbag system was symmetrical.

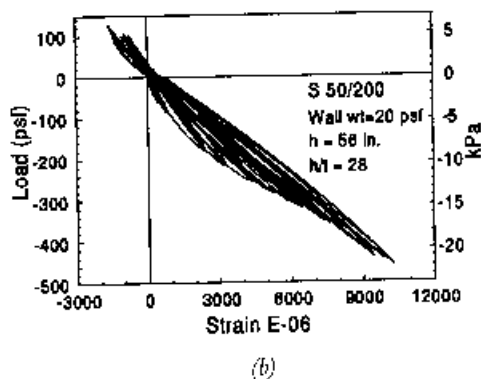
Fig. 9—Typical measurements for Specimen S 50/200; (a) load versus deflection at midheight; (b) load versus the longitudinal strain in the composite strip; and (c) load versus rotation at the top support.

Delaminated areas reached more than 75% of the area of the composite strips by the end of the test. Longitudinal strain in excess of 1.1% was measured on composite fabric on both wall faces. It is important to remark that the ratios of the applied pressure on both faces for the first major crack, first delamination, and the ultimate load were proportional to the reinforcement ratios. Figure 9 shows typical curves for all measured parameters. The general information is described in Table 3.
