Laboratory Experiments conducted on Reinforced Concrete Pipes

ABSTRACT: Tests were conducted on three concrete pipes to evaluate the potential of composite reinforcement to eliminate shear failure, when the composites are applied to the inside of the pipe. Pipe was used in the experiments to simulate the cylindrical structure of an intake tower. All three concrete pipes contained the least amount of steel reinforcement possible. The first test resulted in pure flexural failure of the pipe. As a result, pipes in the second and third experiments had to be retrofitted with glass laminates to prevent flexural failure. These laminates were positioned on the bottom third of both pipes. After reproducing shear failure of the pipe walls in the laboratory experiments, it was determined that composite reinforcement would not be effective if applied to the inside wall of the pipe. This is because the inside wall of the pipe crushed in compression and did not fail in tension like a typical shear crack. This mode of failure was due to the biaxial bending in the pipe cross section. This behavior is not expected to occur in pipes with a higher thickness to diameter ratio than the 1/10 ratio used

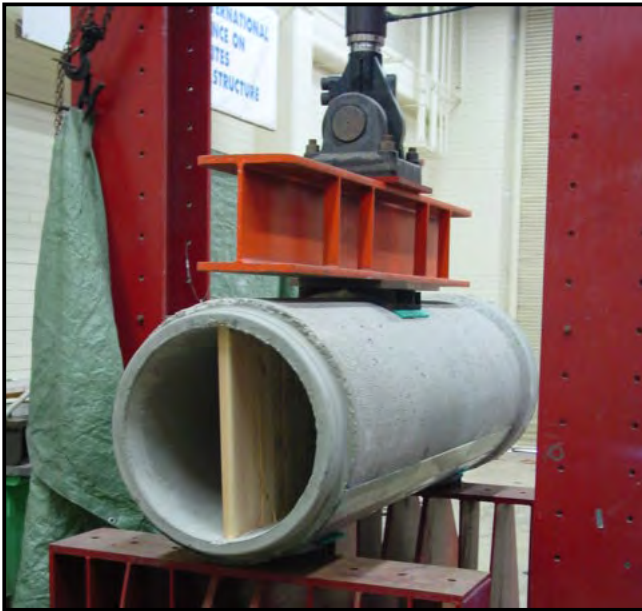
Figure 3. Wood stiffeners used for specimen 3.

nates on specimen 2 were adhered over their full length, while the middle third of the laminates on specimen 3 were intentionally left unbonded (Fig. 2). The laminates covered the lower third of each pipe. Specimen 3 was also retrofitted with wood (2x4) vertical stiffeners (see figure 3) to prevent localized punching failure, which was observed in the second experiment. The middle one third of the glass laminates was not bonded to simulate the possible defects during installation. This imperfection, however, did not affect the results, thereby indicating certain redundancy in this structural retrofit system.

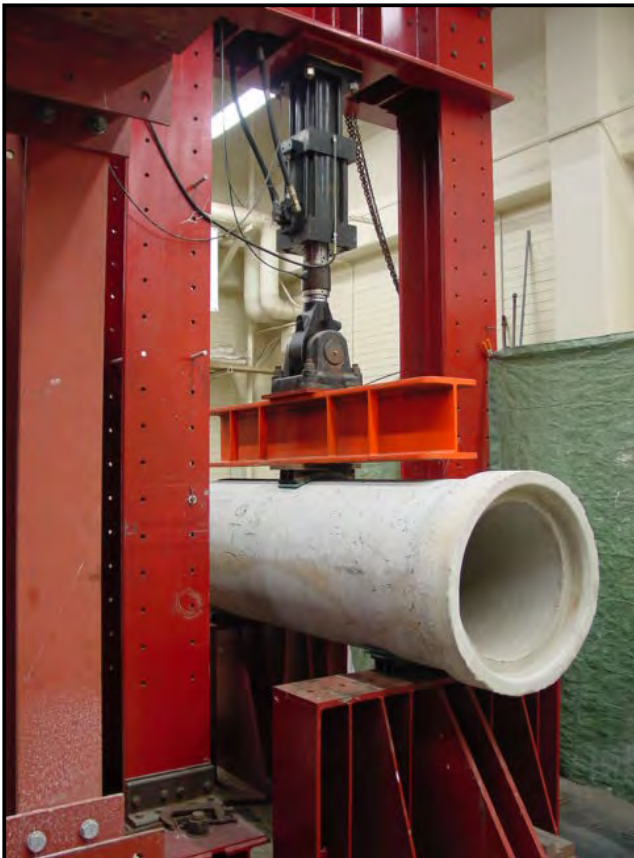
Figure 4. Test setup. Specimen 1 shown.

The beam test was conducted in the vertical load frame shown in Figure 4. This particular test frame is equipped with a 110 kip MTS actuator, which is supplied by a 30 gpm hydraulic pump. Load was ap-

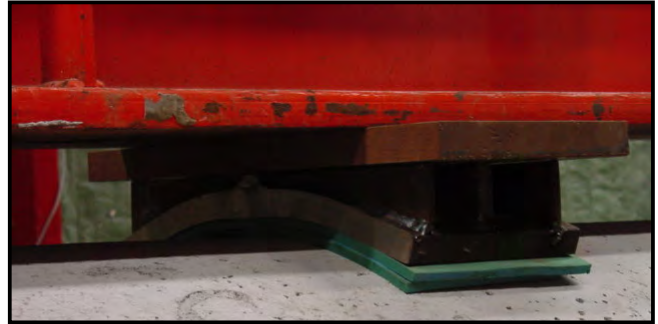
Figure 5. Pre-shaped supports.

plied at midspan with no lateral bracing. Pre-shaped supports were used at all load and reaction locations (Fig. 5). These supports were fabricated specifically to match the outer diameter of the pipes.

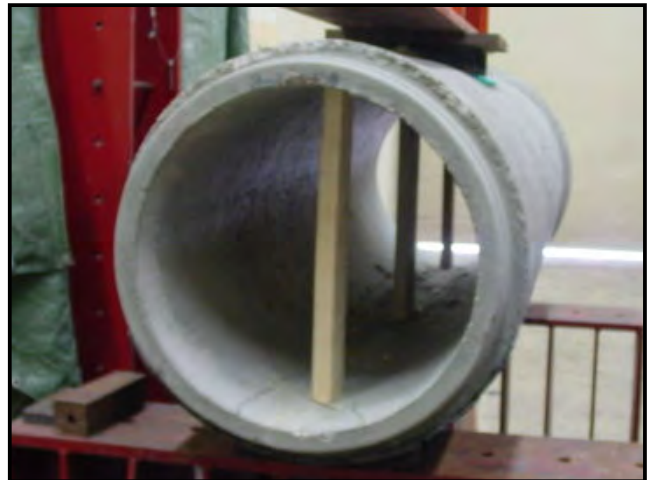
Figure 6. Test 3 of Specimen 3, with all but four vertical stiffeners removed.

The span used for all three tests was 60"; however, the third specimen did not fail at that span. Hence, the span was then lengthened to 70" and specimen 3 was tested another two times. In the last test of specimen 3, all but four of the 2x4 wood stiffeners were removed (Fig. 6).

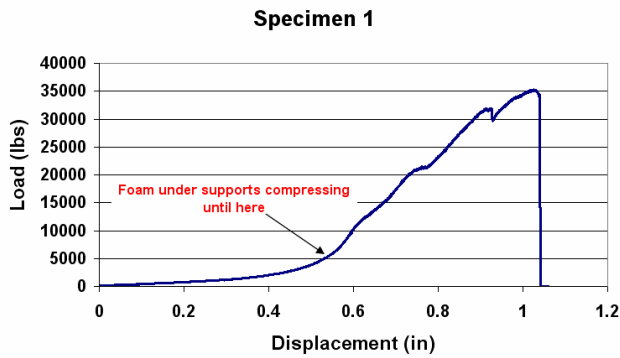
Figure 7. Load-Displacement Curve for Specimen 1.

Specimen 1. Without knowing the exact location and orientation of the internal steel reinforcement, it was assumed that the pipe would undergo a shear failure due to the short span. However, the minimal amount of longitudinal reinforcement was not sufficient to support this failure-mode, and the pipe failed flexurally (see figures 7 & 8). Specimen 1 achieved a 35.2 kip load before the failure, without any added reinforcement.

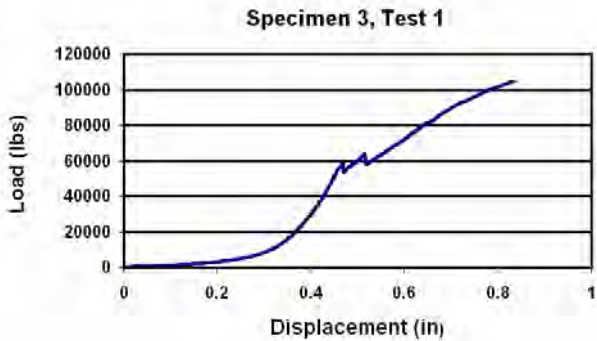
Figure 12. Load-displacement curve of Specimen 3, Test 1.

Specimen 3; Test 1. Even after testing Specimen 2, the controlling failure mode was not well-defined. Because the intent was to develop a shear failure only, the third specimen was retrofitted to eliminate flexural, squashing and bearing failures. The third pipe was strengthened with the same glass plates to prevent flexural failure, except the middle third of the plates was left unbonded (Fig. 2). The pipe was also fitted with a row of vertical wood stiffeners, centered within the pipe in the plane of applied load (Fig. 3). Although these stiffeners may have been sufficient, another load plate was made and used to distribute the applied load over a larger surface area in an effort to prevent another bearing failure at that location. The first test of the third specimen showed that the pipe had been over-reinforced as it climbed to a maximum load of 104.6 kips with only minor cracking between 60 to 65 kips, as shown in figure 12.

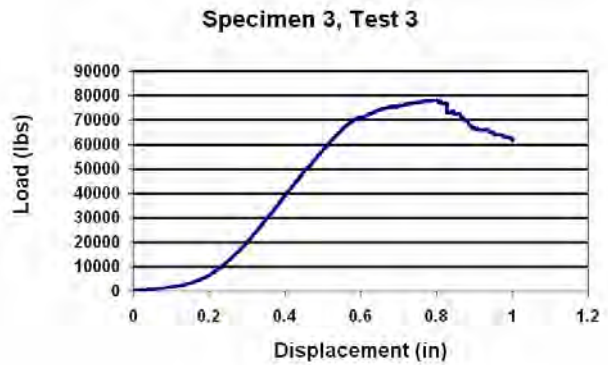
Figure 14. Load-displacement for Specimen 3, Test 3.

but four of the vertical wood stiffeners for the third test. The full row of stiffeners greatly enhanced the shear capacity of the beam and created an unrealistic model of the actual case. This proved to be true in the third test as the pipe reached a significantly lower maximum load of 78.4 kips (Fig. 14). A decreased load capacity was expected during the test because a dramatic widening of the shear cracks was observed (Fig. 15). Some localized punching failures were also observed at the locations of the vertical stiffeners (see figures 16 & 17).

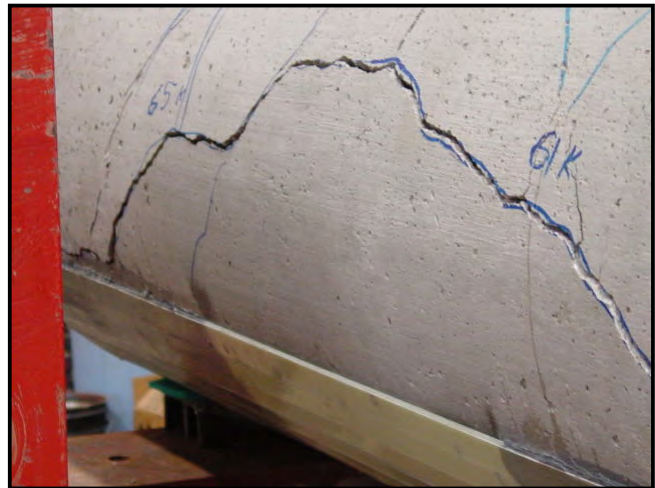
Figure 15. Enlarged shear crack in Specimen 3, Test 3.

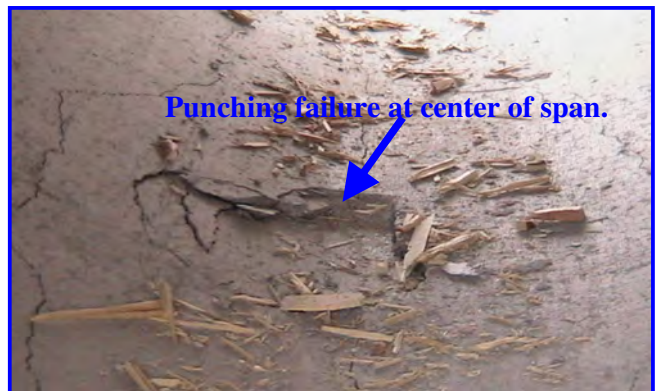
Figure 16. Punching failure under vertical stiffeners of Specimen 3, Test 3.

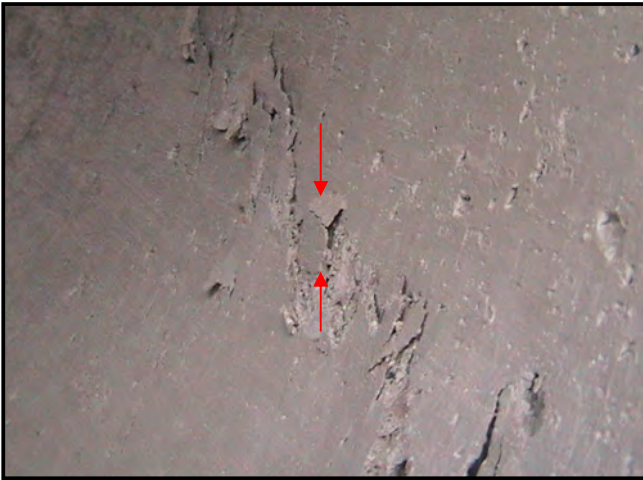
Figure 18. Spalling of concrete on inner wall of Specimen 3, along the shear crack.

Nevertheless, it was observed that the inner walls of the pipe were often in compression when the shear failures occurred. This was obvious for two reasons. First, the shear cracks were open on the outer wall and closed on the inner wall. Secondly, the spalling concrete on the inner wall along the shear crack appeared to buckle before dislodging (Fig. 18). It is the author's belief that this compres-
