Seismic Retrofit of URM Walls with Fiber Composites

by M. Ehsani¹, Ph.D., P.E. and H. Saadatmanesh², Ph.D., P.E.

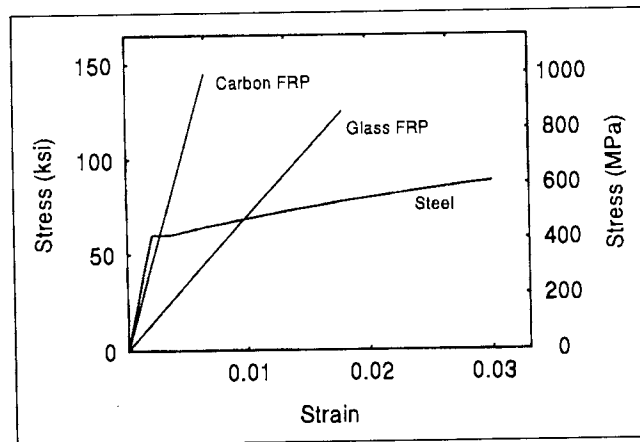
Fig. 2—Stress versus strain behavior of steel and composites

There are, of course, other fibers such as carbon that in composite form are both stronger and stiffer than glass. However, these fibers are rather expensive and may have limited application in the construction industry where large volumes of inexpensive material are needed. Fig. 2 shows typical stress versus strain diagram for glass and carbon fiber-reinforced composites (GFRP and CFRP, respectively) and steel.

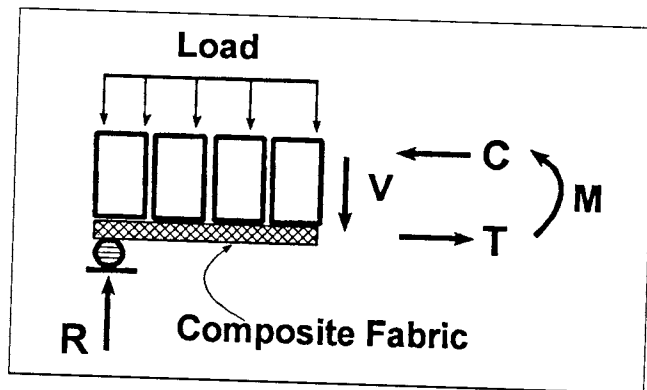
Fig. 4—Mechanism for resisting flexure

Recognizing the high tensile capacity of fiber composites, a thin layer of these materials (in fabric form) can be epoxied to the exterior surface of the wall (Fig. 3). The fabric could contain fibers positioned in both horizontal and vertical directions to increase both the flexural and shear strength of the wall. As shown in Fig. 4, for a wall subjected to bending, the internal tensile stresses in the composite

fabric will be resisted with internal compressive stresses in the masonry, resulting in a resisting moment. For an element subjected to diagonal tension or shear, the forces along the inclined crack are resisted by the sum of the forces developed in the individual horizontal and vertical fibers of the fabric (Fig. 5). In this case, the composite fabric acts the same way as a grid of steel reinforcing bars embedded within the wall, with the rebar placed in the horizontal and

vertical directions. The degree of strengthening can be designed according to the strength of the composite fabric being used and of the substrate material. The principles illustrated in Figs. 4 and 5 are applicable to all types of substrates, such as bricks, concrete block, and hollow clay tiles.

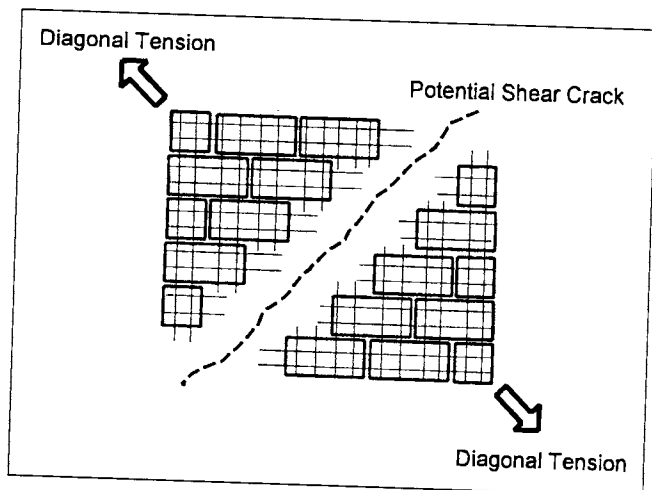
Fig. 5—Mechanism for resisting shear

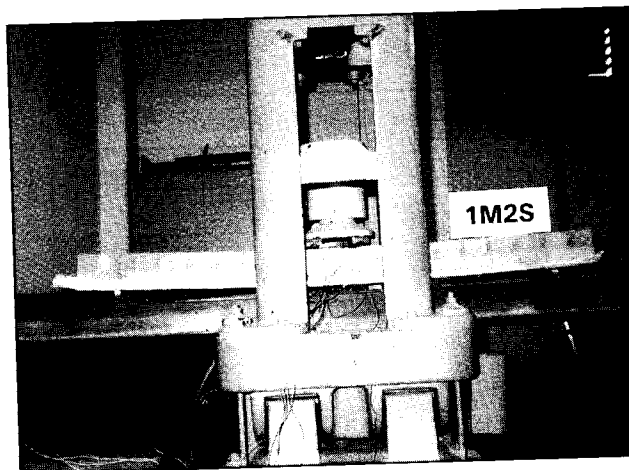
Fig. 6—Test setup for flexural tests

The out-of-plane flexural behavior of unreinforced masonry (URM) walls was studied by testing small URM beams. The beams consisted of 19 solid clay bricks, each with a dimension of 2.5 × 4 × 8.5 in. (63 × 102 × 216 mm), stacked in a single wythe (stack bond). This resulted in beams that were 8.5 in. (216 mm) wide, 4 in. (102 mm) high and 57 in. (1.45 m) long. The beams were loaded statically to failure with two concentrated loads over a clear span of 47 in. (1.19 m) (Fig. 6).

The beam specimens were subjected to four-point bending as shown in Fig. 6. Before discussing the results, the reader is reminded that when spanned horizontally in the testing frame, the unretrofitted test specimens would normally fail under their self weight of approximately 125 lbs (556 N). Therefore, prior to strengthening, the specimens had to be handled very carefully. The first fabric, used in Specimen 2M1S, was relatively weak. Nonetheless, the specimen carried a maximum load of 700 lbs (3114 N) and had a deflection of 0.27 in. (7 mm) at failure (Fig. 7). The ultimate load was defined as tension failure of the fabric. Based on this test, stronger fabrics were used in the remaining tests.

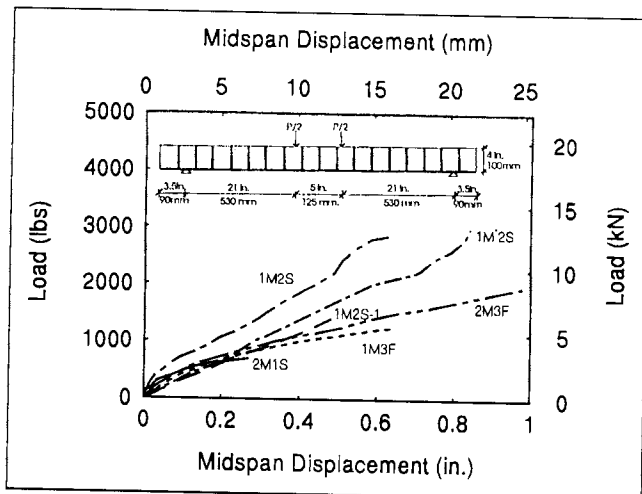
Fig. 7—Load versus deflection for retrofitted URM beams

The influence of the strength of the fabric can be readily seen by comparing Specimens 1M2S and 1M3F, both retrofitted with the same epoxy (i.e. Type 1). The thicker fabric in 1M2S resulted in a failure load of 2850 lbs (12.67 kN) and a deflection of 0.63 in. (16 mm). Failure began with compression crushing of the bricks near the top of the beam, followed suddenly by diagonal cracking of the beam in the shear span (Fig. 8). Specimen 1M3F had less stiffness due to the thinner fabric used. This specimen reached a maximum load of 1320 lbs (5.87 kN) and a deflection of 0.65 in. (16.5 mm). At that point, the fabric failed in tension.

The performance of the second epoxy was superior to that of the first. This was evident from comparison of the results for Specimens 1M3F and 2M3F. Both specimens were retrofitted with the lighter E-glass fabric. The performance of Specimen 1M3F was discussed above. Specimen 2M3F had a higher stiffness and reached a load of 1950 lbs (8.67 kN) at a deflection of 0.98 in. (25 mm), or 1/48 times the span (Fig. 7). Thus, the failure of the specimen was ductile and accompanied by large deflection. Both specimens failed by tension failure of the glass fabric. However, the additional

load carried by Specimen 2M3F and its higher deflection at failure were attributed to the type of epoxy used in this specimen.

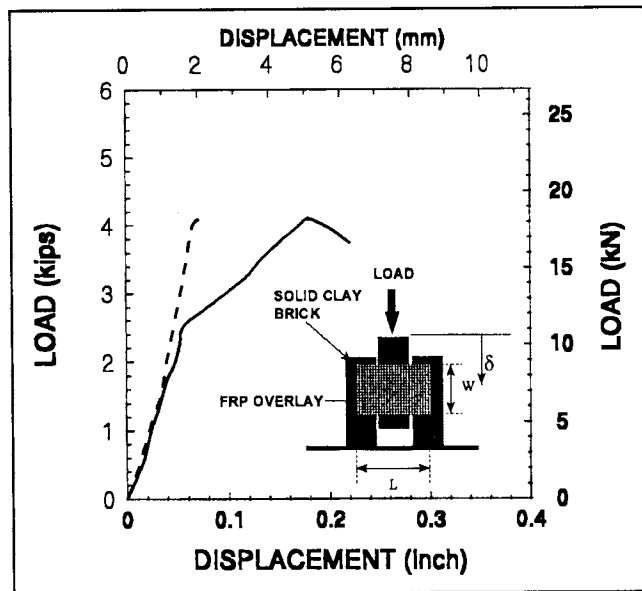
Fig. 9—Load versus deflection for shear tests

The laboratory specimens consist of three solid clay bricks which are covered with a composite fabric on both faces (Fig. 9). The fabric pieces are each 4.5 in. (114 mm) wide and 8 in. (203 mm) long. Several fabrics and epoxies have been tested. The results shown in Fig. 9 are for a fabric that weighs 10 oz/yd² (339 g/m²) and has equal volume of fibers in the warp and fill directions. The applied load versus the deflection at the top of the middle brick has been plotted for two specimens. The solid line represents a specimen in which half of the fibers within the fabric were parallel and the other half were perpendicular to the axis of loading; the dashed line is the behavior of a specimen with the fibers crossing the shear plane at 45 and 135 degrees. In order to expedite the construction of the test specimens, no mortar joints were used. Instead, the bricks were separated from one another with lubricated spacers having a thickness of 3/8 in. (10 mm). Consequently, the resistance of the specimens was fully attributed to the composite fabric. In the test setup used, a steel clamping device was used to

In both cases, the specimens resisted substantial forces prior to failure. Failure of the 0-90 specimen occurred as a result of a tearing of the composite fabric at the interface of the bricks. Failure was not brittle since the load resisted by the specimen increased up to a displacement of 0.2 in. (5 mm), with a reduction in stiffness after a displacement of 0.05 in. (1.3 mm), where the tearing of the fabric began. The 45/135 specimen had a higher stiffness. This is because with that orientation of the fabric, the fibers are subjected to direct tension, where the stiffness of the fibers is largest. Both specimens shown in Fig. 9 carried loads in excess of 4000 lbs (17.8 kN). A large number of such specimens incorporating fabrics with different strengths have been tested; the experimental results and the analysis of those specimens are presented elsewhere [25]).

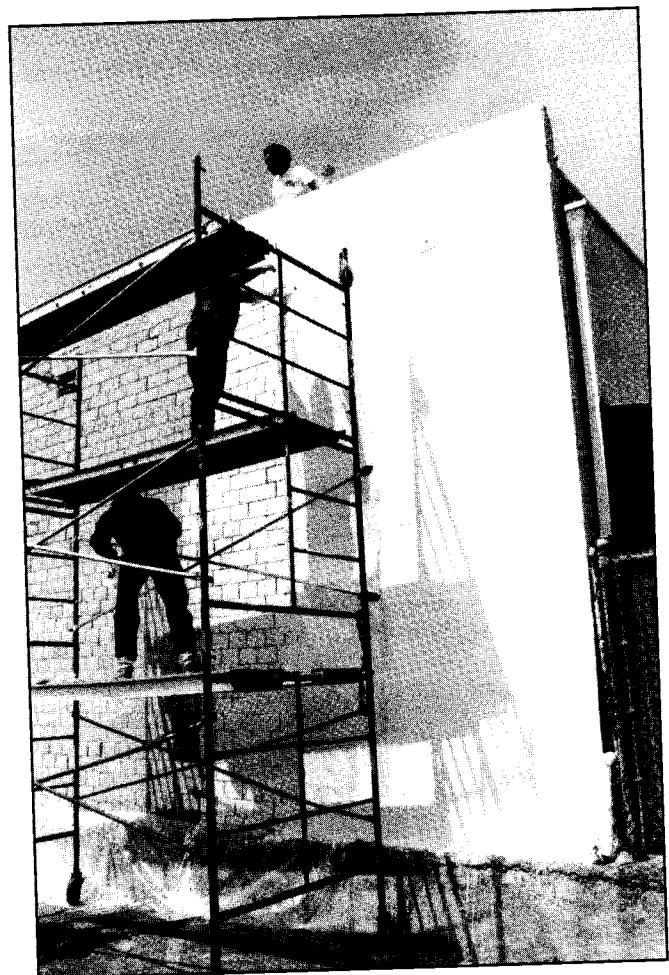
Fig. 12—Application of *QuakeWrap*™ to the wall (Photo courtesy of External Reinforcement, Inc.)

loose and were reset, and the shear cracks in the wall were filled with mortar. The two-part epoxy was mixed in the field and applied in thin layers to the wall. The 3-ft. (915-mm) wide fabrics were then placed on the wall in vertical strips and pressed against the uncured epoxy. In a similar fashion, the next strips of fabric were added with sufficient overlap with the adjacent strips to form a continuous fabric on the wall (Fig. 12). The nuts and washer plates associated with seismic anchors from the earlier retrofit were temporarily removed and were replaced after the composite fabric was installed. The bottom edge of the fabric was anchored to the existing footing with a steel anchor plate and bolts. On the exterior surface, the top edge of the fabric was anchored to the existing wall parapet. On the interior, the top of the fabric was wrapped around blockings which were fastened to the floor joists. Fig. 13 shows the interior wall surface at the completion of the project; the conveyor belt system and the bolts and straps which were used in the earlier retrofit to tie the roof to the wall can also be seen.

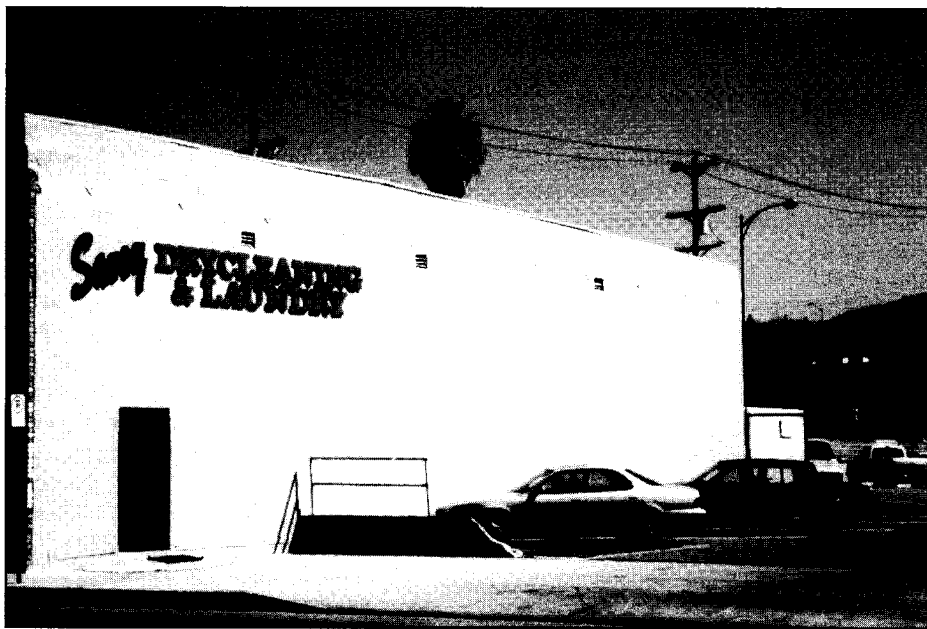
Fig. 14—Exterior of wall at completion of project (Photo courtesy of External Reinforcement, Inc.)

Once the fabrics were attached to the wall, a second coating of epoxy was applied to the exterior surface so that the fabric was totally impregnated with the epoxy. Finally, the exterior surface of the wall was covered with a special ultraviolet-protective coating; the coating color was selected to match the original color of the building. Fig. 14 shows the wall upon complete installation of *QuakeWrap*™ after the application of the ultraviolet-protecting paint.
