SHEAR BEHAVIOR OF URM RETROFITTED WITH FRP OVERLAYS

By M. R. Ehsani,¹ Member, ASCE, H. Saadatmanesh,² Member, ASCE, and A. Al-Saidy³

ABSTRACT: A large inventory of older masonry buildings exists in earthquake-prone regions. In most cases these buildings contain shear walls constructed of unreinforced masonry. The majority of these buildings were built before any provisions for earthquake loadings were established. The failures and damages reported in recent earthquakes attest to the need for efficient strengthening procedures. The effectiveness of increasing the shear strength of brick masonry by epoxy-bonding fiber-reinforced polymer (FRP) overlays to the exterior surfaces was evaluated. The variables in the test included the strength of the composite fabric, fiber orientation, and anchorage length. The specimens were tested under static loading. The results showed that both the strength and ductility of tested specimens were significantly enhanced with this technique. The orientation of the angle of fibers with respect to the plane of loading had a major effect on the stiffness of the retrofitted system but did not affect the ultimate strength significantly.

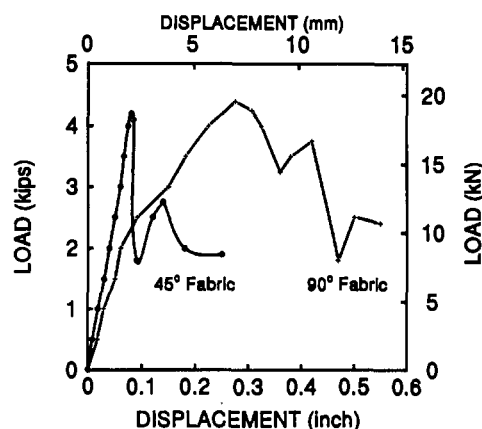
FIG. 3. Typical Load versus Displacement Graph

The description of test specimens is summarized in Table 2. Typical measured load versus displacement of the top of the middle brick for specimens with the fibers oriented at 45 and 90° are shown in Fig. 3. As can be seen several load peaks are presented in the descending portion of each graph. For clarity, it was decided to report each graph only up to the ultimate (peak) load value. The load versus displacement curves for 24 specimens that were considered for the analysis are presented in Figs. 4–6.

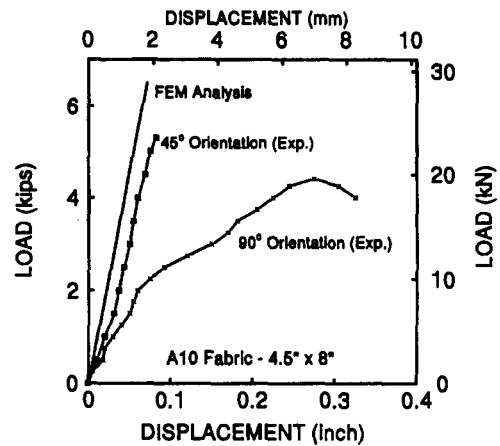
FIG. 13. Comparison of FEM and Experimental Results

The load versus displacement obtained from FEM is compared with the experimental results in Fig. 13. The predicted load versus displacement curve is compatible with the experimental results in the case of the 45° fiber orientation. The slight difference in the slope is attributed to the imperfect bond between the brick and the laminate in the test specimens; the FEM solution assumed perfect bond. The measured response is linear as was assumed in the analysis. There is clearly a difference between the FEM solution and the experimental results for specimens with 90° fabrics. It was shown that fibers oriented at 90° were stressed in shear, hence the response was expected to be nonlinear. Thus, the FEM model that assumes linear behavior for the FRP laminates is only valid for specimens with fibers oriented at 45°.
