Fiber Composite Plates for Strengthening Bridge Beams

Mohammad R. Ehsani & Hamid Saadatmanesh

Department of Civil Engineering and Engineering Mechanics, The University of Arizona, Tucson, Arizona 85721, USA

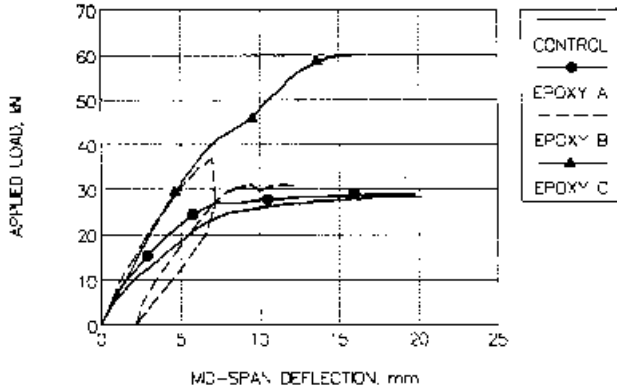
In Fig. 3, the load versus deflection responses of beams A, B, and C are compared with that of the control beam. The epoxy used for beam A was fairly flexible. The uncured epoxy had a relatively low viscosity and could easily flow under a slight pressure. The cured epoxy was black and had a rubbery texture. The required curing time was 24 hours at 25°C. As Fig. 3 indicates, the initial stiffness of beam A was slightly higher than that of the control specimen. The stiffness of both beams reduced after the concrete cracked at a load of approximately 7 kN. The load-deflection response continued almost linearly until the longitudinal steel yielded. At that point, due to large tension cracks, the bond between the plate and the beam failed gradually in a ductile manner and the GFRP plate separated completely from the beam. The failure was in the adhesive without any damage to either the concrete or plate surfaces. Consequently, the control beam and beam A had virtually the same failure load. It was concluded that because this particular epoxy was too flexible, no measurable shear could be transferred between the plate and the beam and therefore, no increase in the ultimate capacity could be achieved.

Figure 3 indicates a substantial increase in the stiffness of the strengthened beam compared with beam A. At a load of approximately 36 kN, large shear cracks were observed in the beam and failure was imminent. The premature shear failure is attributed to the flexural strengthening of the beam without shear strengthening. At this point, the beam was completely unloaded and the regions of shear distress were strengthened by means of external clamps. The beam was then reloaded and the loading continued until the beam failed at a load of 31 kN. The failure was caused by the separation of the plate and the beam, particularly around the base of the shear cracks where the concrete to plate bond had been severely damaged in the first cycle of loading.

Fig. 3. Load versus mid-span deflection for the small-scale beams.

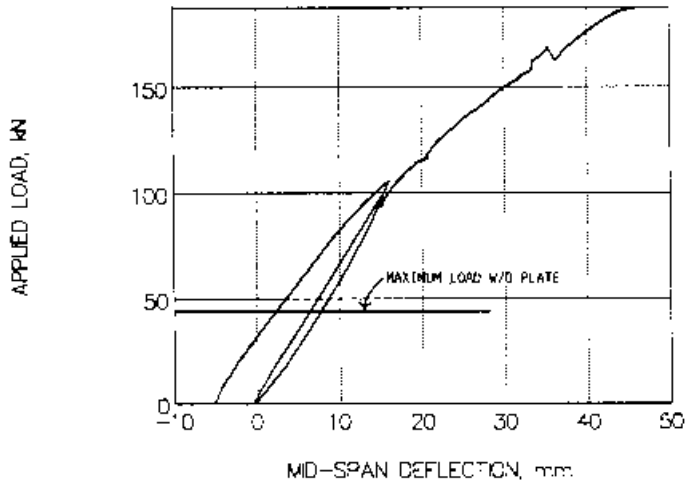
As shown in Fig. 5, the external prestressing resulted in a negative (i.e. upward) deflection of 5 mm in the beam before it was loaded. Because the area of tension reinforcement for this beam was relatively low, the beam without the GFRP plate would have failed at a load of 44 kN only. The stiffness of the strengthened beam reduced after the tension face cracked at a load of approximately 18 kN. The post-cracking response of the beam was almost linear with small cracks distributed along the entire length of the beam. The beam failed at a load of 186 kN, which is more than four times the predicted failure load of the beam without the plate. This clearly points to the potential of this technique as a method for rehabilitation and strengthening of structures.

Fig. 5. Load versus mid-span deflection for the large-scale beam.
